FIXING AN ICON

THE UF
ARCHITECTURE
BUILDING

UF 639 Architecture Building Envelope Repairs
 BID PACKAGE 1 - THE ROOF
 DANESVILLE, FL 32807
 01/27/2020

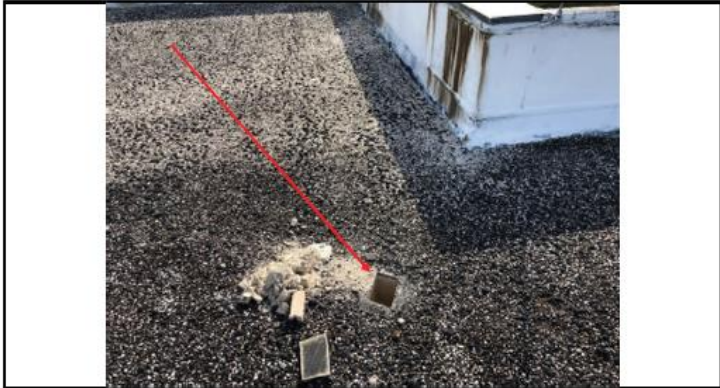
Photo 19: Photo to show general location of Core #1 at the south section of the East Wing roof area. See [Photo 20](#).

Photo 20: General location of core samples #1 and #2 at the East Wing roof area.

Photo 21: Core samples revealed the sloped roof substrate being a Zonolite LWIC material, over approximately 1 inch of Styrofoam insulation, [Photo 29](#). The depth of the roof assembly at Core #1 was approximately 6 1/4 inches.

Photo 22: The depth of the roof assembly at Core #2 was approximately 6 1/4 inches. Based on the distance of approximately 50 feet between the two core samples, see [Photo 20](#), the slope is minimal at 1/4 inch within 50 feet.

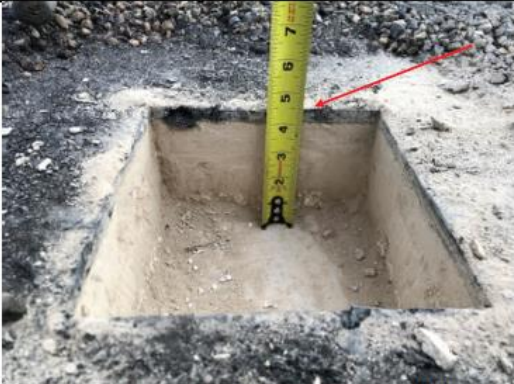
Photo 31: Core #4 was approximately 4 ½ inches in depth. Note the core location shows no evidence of moisture. Core samples #3 and #4 were approximately 19 feet apart. This indicates a slope of approximately 1 inch within 20 feet.

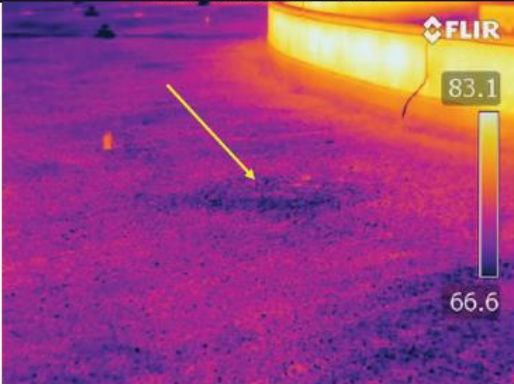
Photo 32: IR image of Core #3 showing thermal anomalies consistent with findings at time of the core sample.

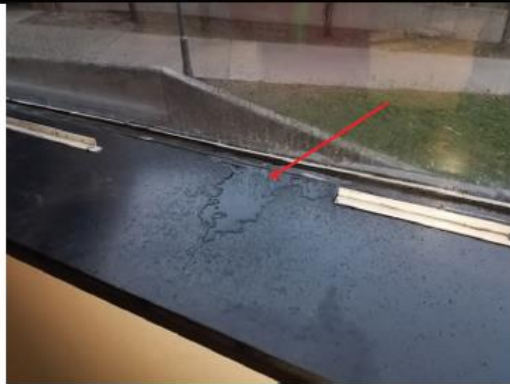
Photo 7: Water migrating from head condition and dripping on sill as a result of the test procedure.

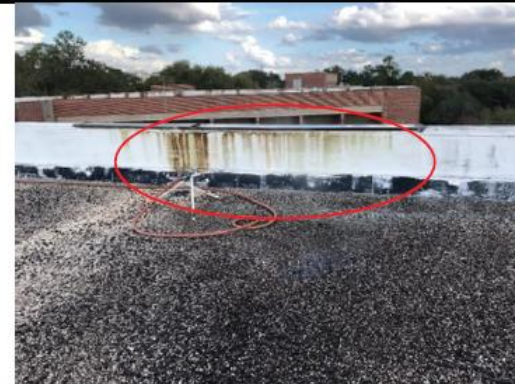
Photo 15: Overview photo of Test Area #3. Test Area #3 included the roof side of the parapet above Test Areas #1 & 2.

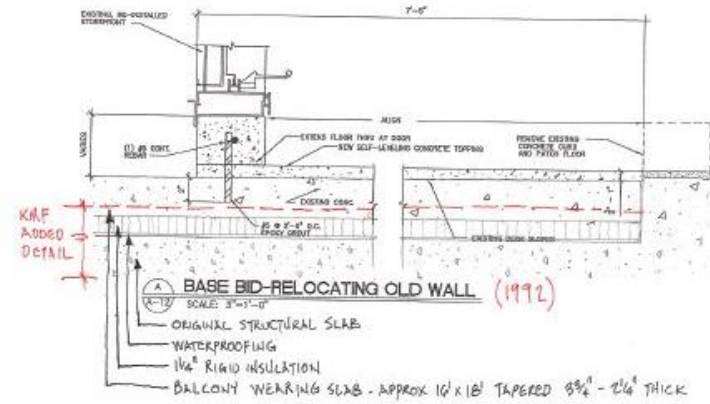
K&F
ADDED
DETAIL

- BASE BID-RELOCATING OLD WALL (1992)
- SCALE: 3/4"=1'-0"
- ORIGINAL STRUCTURAL SLAB
- WATERPROOFING
- 1/4" RIGID INSULATION
- BALCONY WEARING SLAB - APPROX 10' x 10' TAPERED 3/4" - 2 1/4" THICK

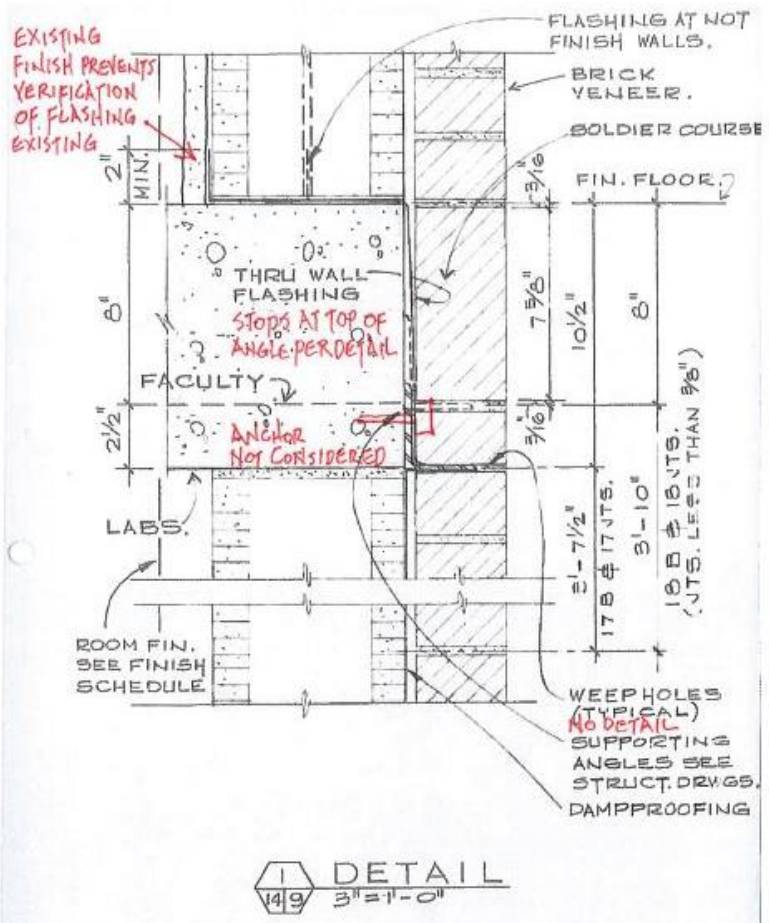
OBSERVATION: NO EVIDENCE OF WEEP HOLES, FLASHING EXTENDING OUT OF BRICK JOINT FOUND IN FIELD. FINISH ON INSIDE OF WALL HIDE ANY EVIDENCE THAT FLASHING EXISTS

- Remove existing material from control joint, clean, and install new sealant and secondary protection
- At existing cracks, remove mortar joint and cracked bricks. Replace brick and install mortar to match
- Remove brick as necessary to install shelf angles, flashing, weeps etc. Replace brick and install mortar to match
