FIXING AN ICON

THE UF
ARCHITECTURE
BUILDING

UF 639 Architecture Building Envelope Repairs
 BID PACKAGE 1 - THE ROOF
 DANESVILLE, FL 32807
 01/27/2020

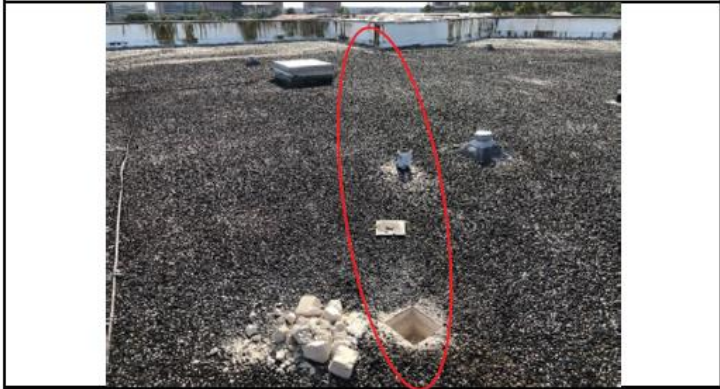
Photo 20: General location of core samples #1 and #2 at the East Wing roof area.

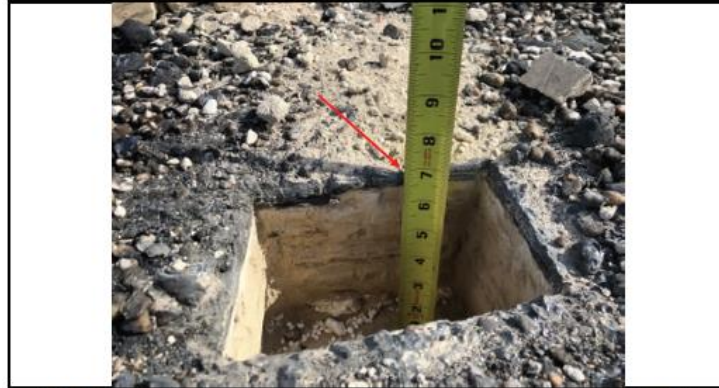
Photo 21: Core samples revealed the sloped roof substrate being a Zonolite LWIC material, over approximately 1 inch of Styrofoam insulation, [Photo 29](#). The depth of the roof assembly at Core #1 was approximately 6 1/4 inches.

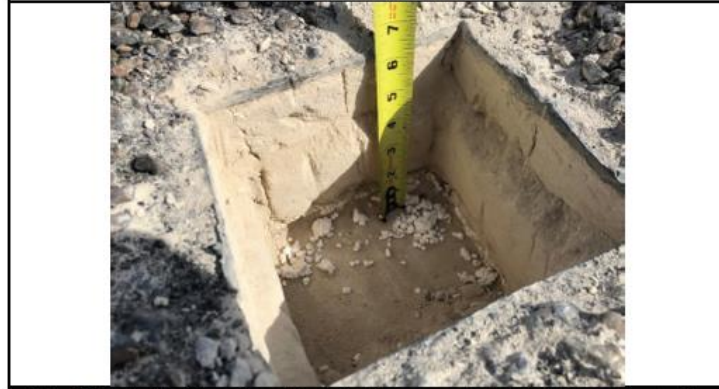
Photo 22: The depth of the roof assembly at Core #2 was approximately 6 1/4 inches. Based on the distance of approximately 50 feet between the two core samples, see [Photo 20](#), the slope is minimal at 1/4 inch within 50 feet.

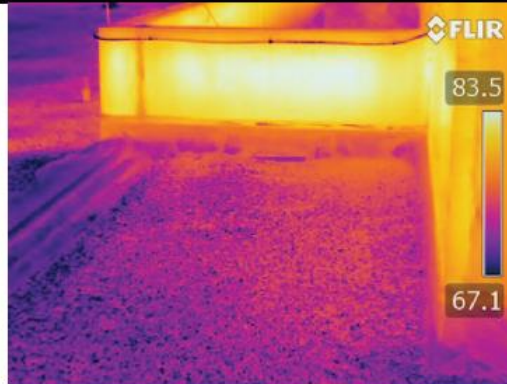
Photo 59: IR image at transition to the center area of the roof looking south along the parapet wall. The wall is showing high temperatures. While thermal anomalies are present, portions of the anomaly could be a result of reflectivity of the wall on the roof.

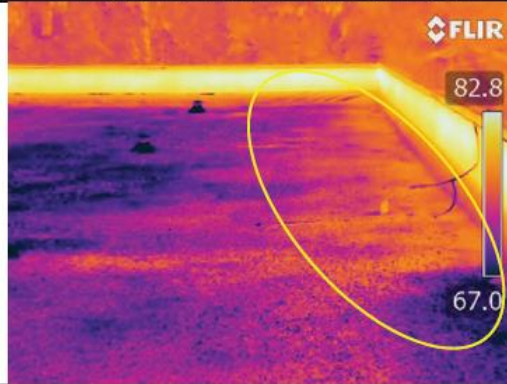
Photo 60: IR image of center transition of the roof north of the courtyard. This image is looking north along the east parapet.

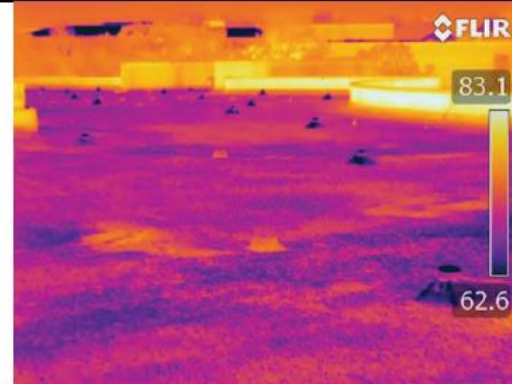
Photo 61: Various thermal anomalies throughout the roof area looking west along the center section of the roof area.

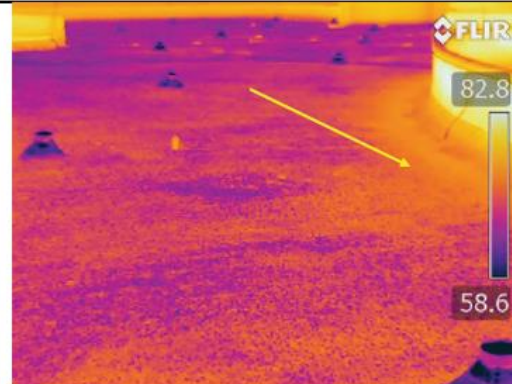
Photo 62: Visible anomalies along the north section of the center roof area.

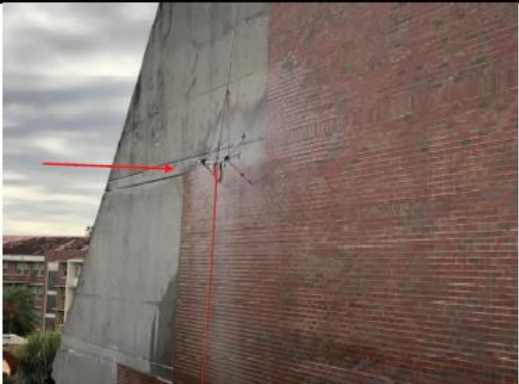
Photo 3: Approximately 1 hour into the test procedure, the spray rack was moved vertically approximately 10 feet and focused on the interface of the brick veneer to the poured in place concrete.

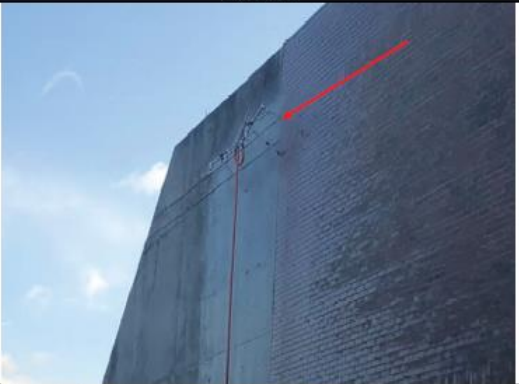
Photo 4: Approximately 3 hours into the test procedure, the spray rack was moved vertically approximately 10 feet and focused on the poured in place concrete. The vertical transition between the brick veneer and concrete was included in the test area.

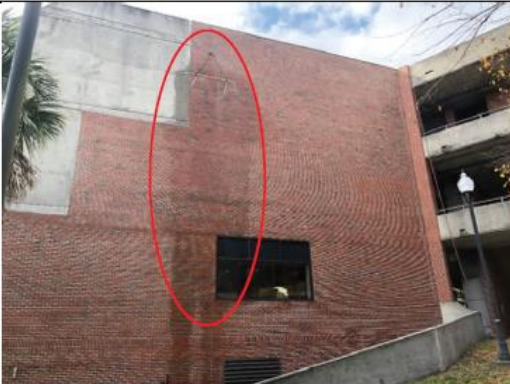
Photo 8: Overview photo of Test Area #2. The spray rack was positioned approximately 5 feet above the fourth-floor line and focused on the brick veneer approximately 6 feet adjacent to Test Area #1.

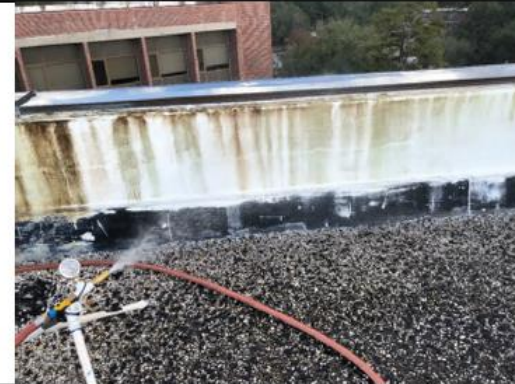
Photo 16: General photo to show position of hand-held nozzle directed at parapet. See [Photo 17](#) for pressure at gauge.

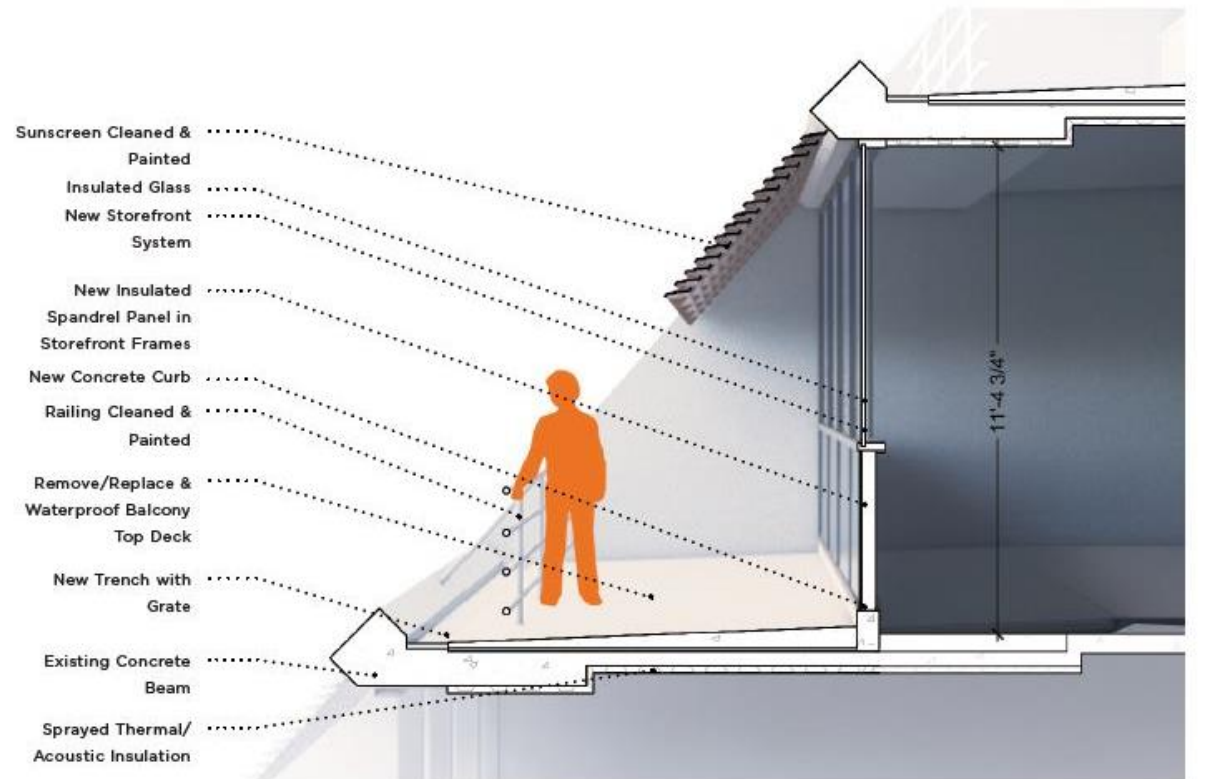
BALCONY SECTION

- BASE BID-RELOCATING OLD WALL (1992)
- SCALE: 3/4"=1'-0"
- ORIGINAL STRUCTURAL SLAB
- WATERPROOFING
- 1/4" RIGID INSULATION
- BALCONY WEARING SLAB - APPROX 10' x 10' TAPERED 3/4" - 2 1/4" THICK

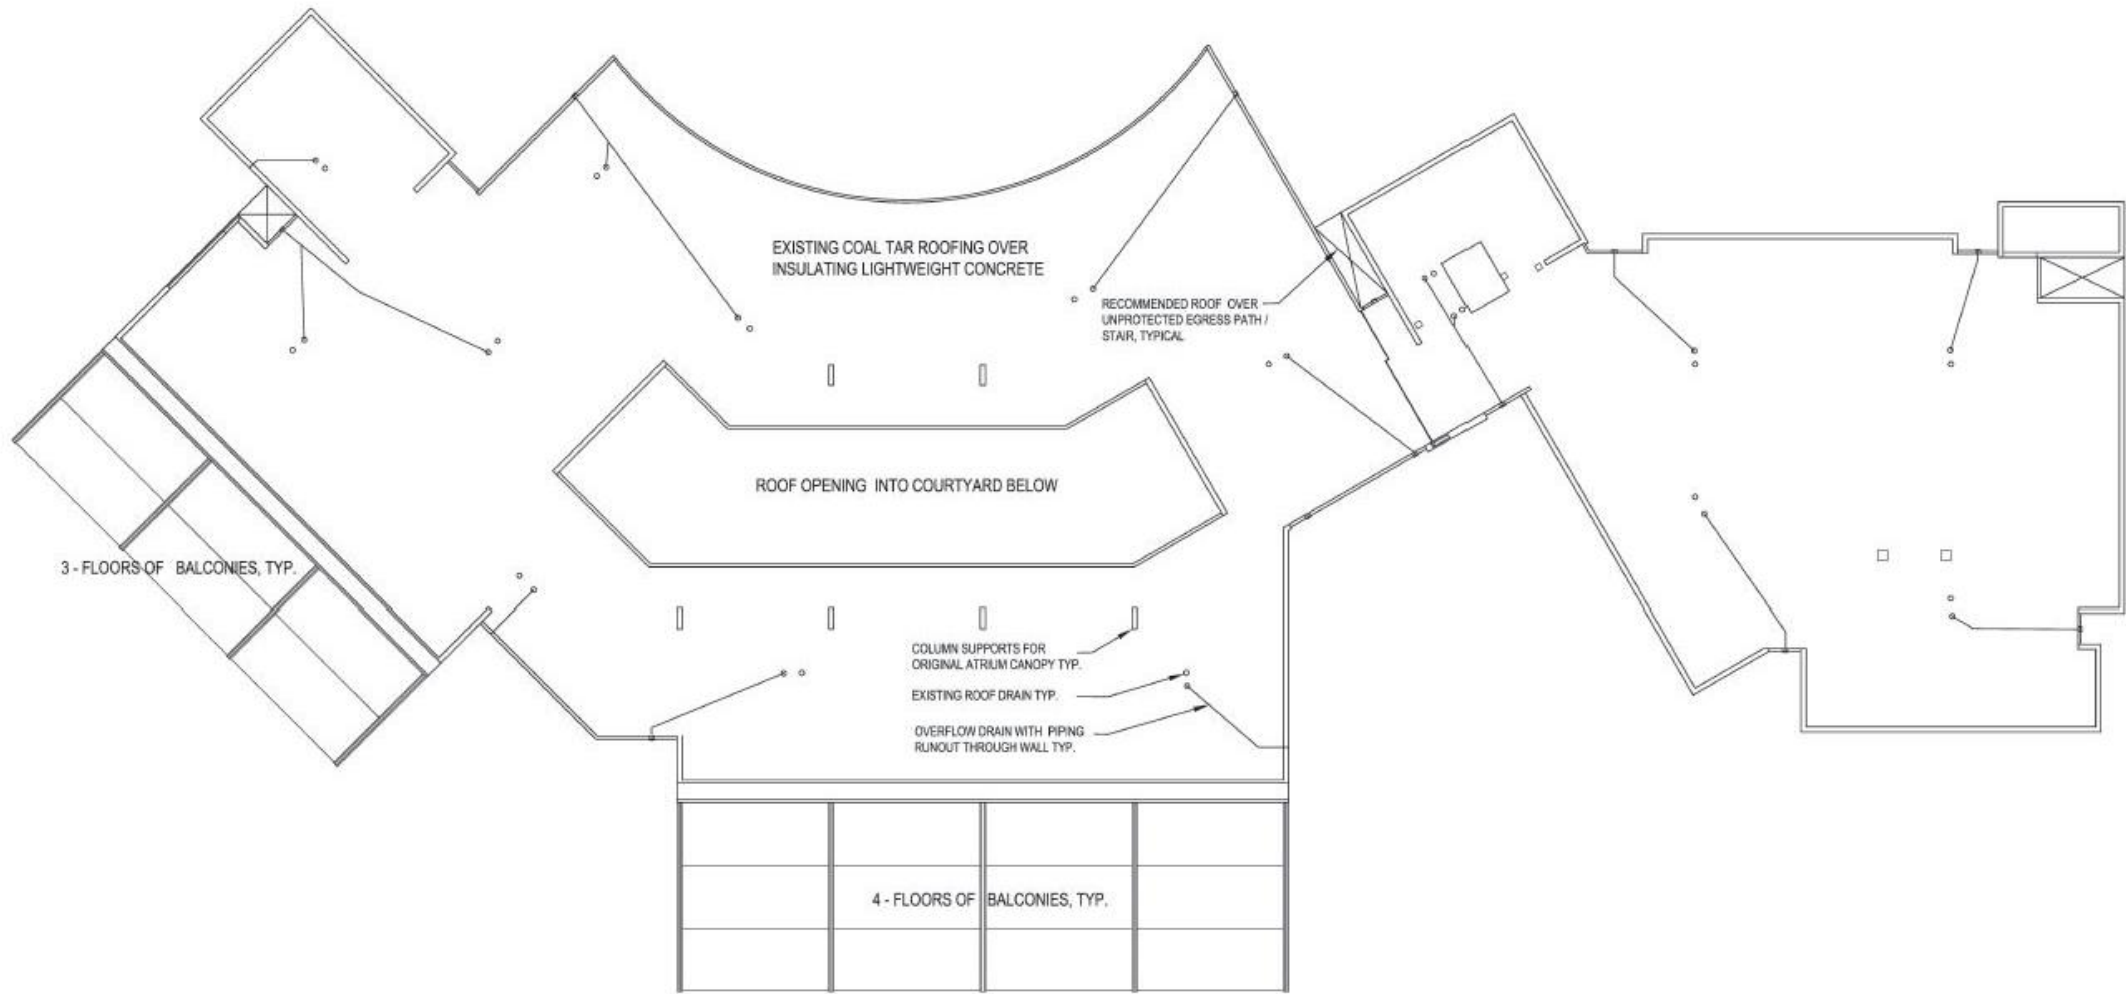
ROOF PLAN - N.T.S.

- 40 years old and in need of replacement
- Built-up roof is nearly flat

1. Lightweight pour over existing roof
2. Remove existing to existing lightweight and reroof with lightweight
3. **Remove to structural deck and reroof with lightweight**
4. Remove existing lightweight and replace with 3 ply SBS Modified Bitumen

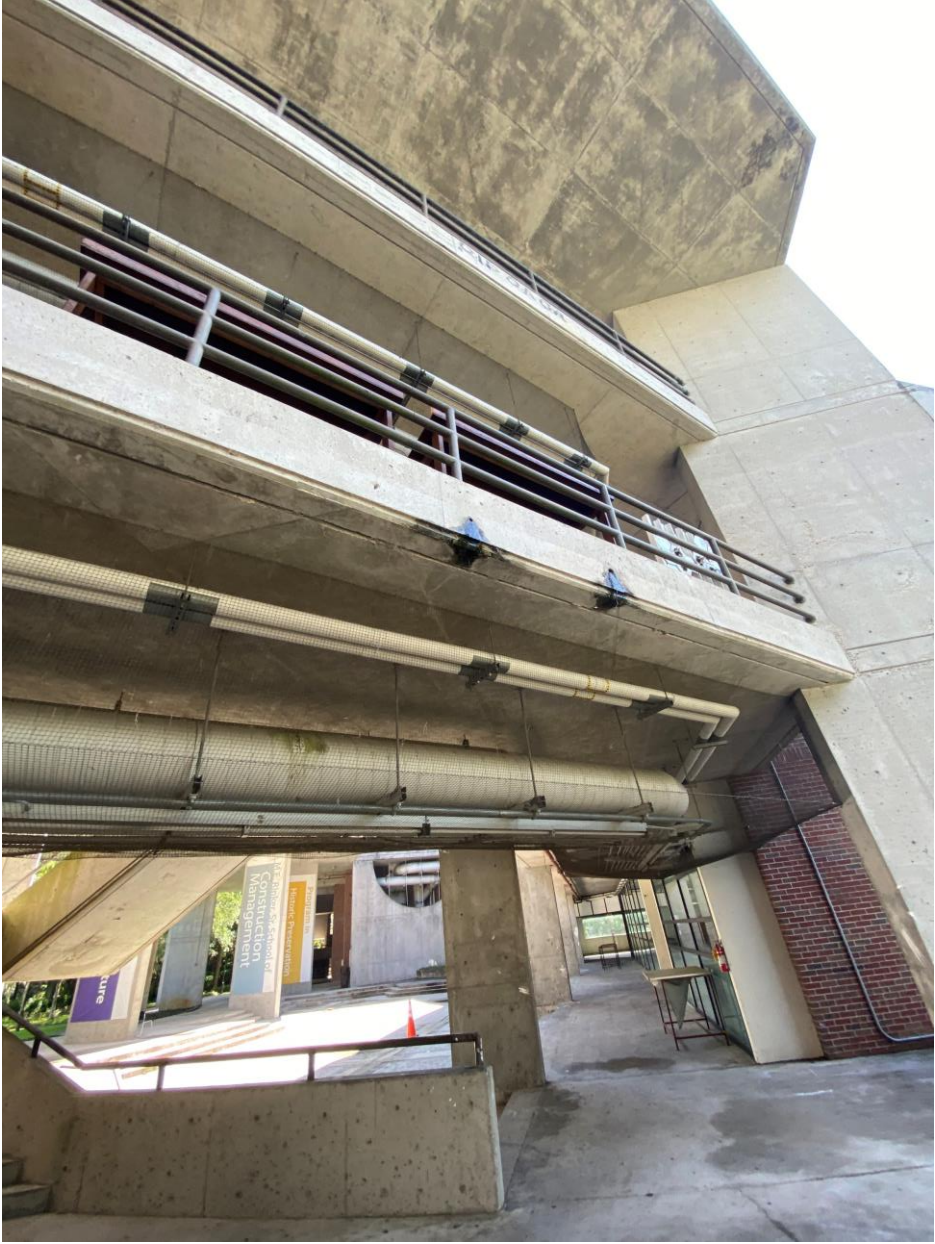
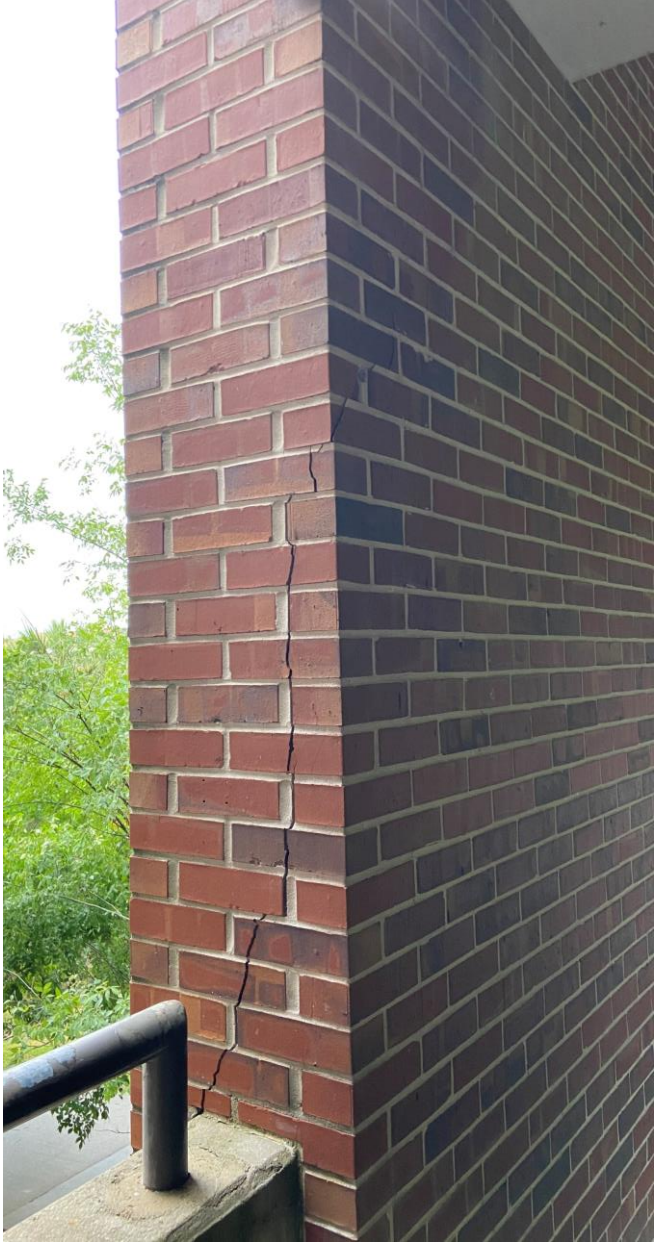
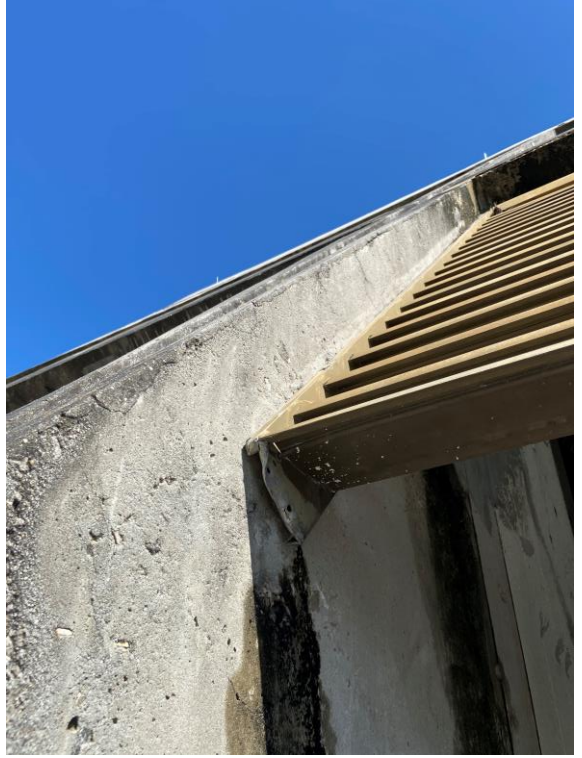
- Exposed Rebar
- Dissimilar Material Separation
- Missing Elements
- Spalling
- Improper Materials

- Exposed rebar has led to additional moisture intrusion
- Brick and concrete are cracking/ separating causing moisture intrusion
- Missing ledge angles, flashing, weeps, etc. have caused differential settlement, separation of materials and the lack of the ability of the wall to expel water
- Field brick used at the head of walls

- Remove existing material from control joint, clean, and install new sealant and secondary protection
- At existing cracks, remove mortar joint and cracked bricks. Replace brick and install mortar to match
- Remove brick as necessary to install shelf angles, flashing, weeps etc. Replace brick and install mortar to match

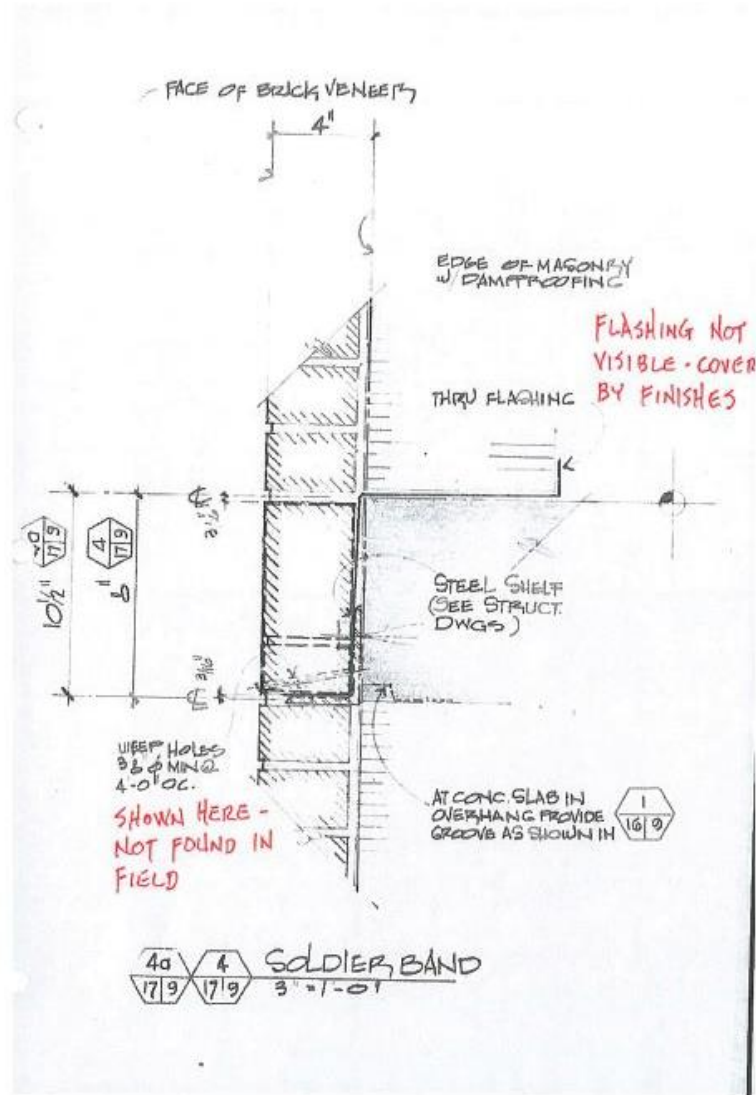
OBSERVATION: NO EVIDENCE OF WEEP HOLES, FLASHING EXTENDING OUT OF BRICK JOINT FOUND IN FIELD. FINISH ON INSIDE OF WALL HIDE ANY EVIDENCE THAT FLASHING EXISTS

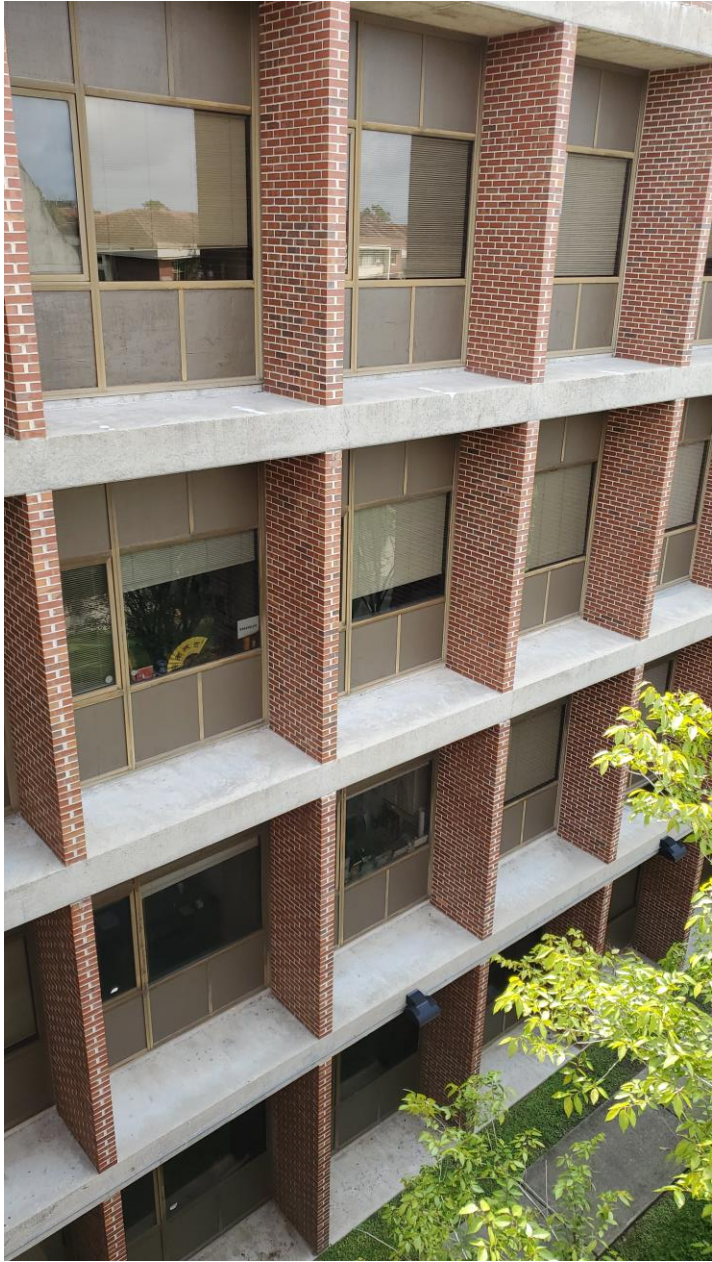
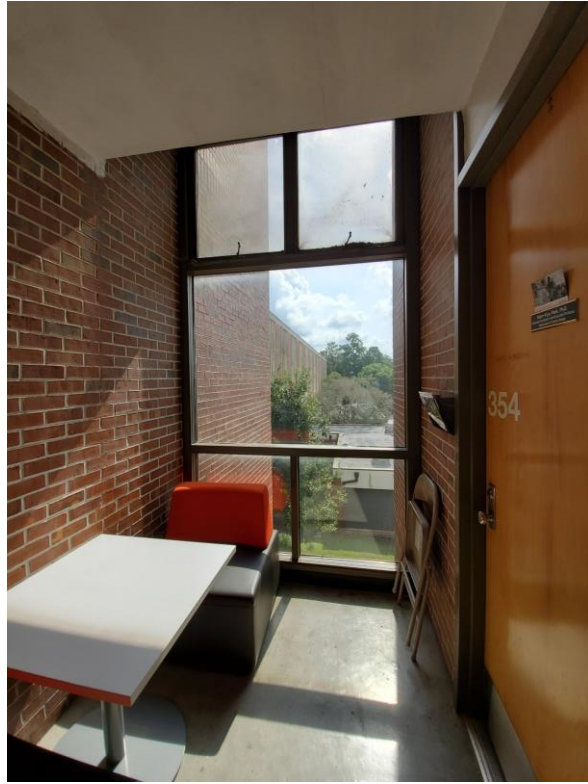
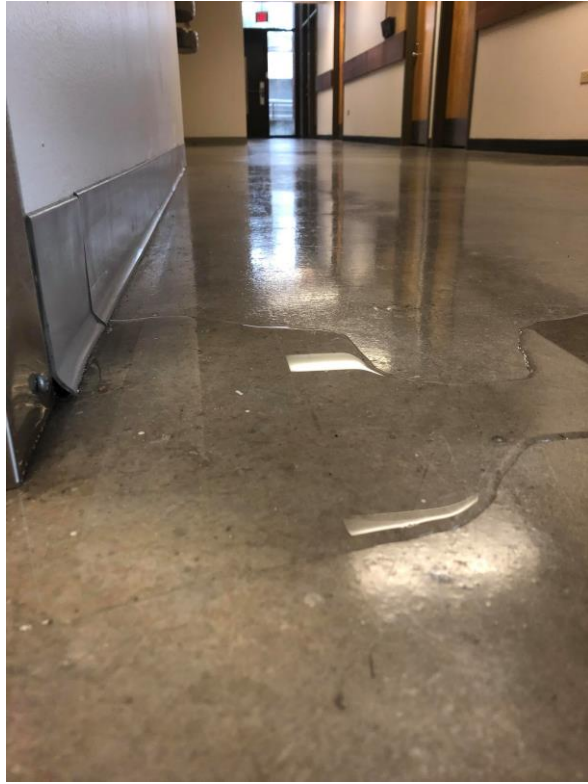
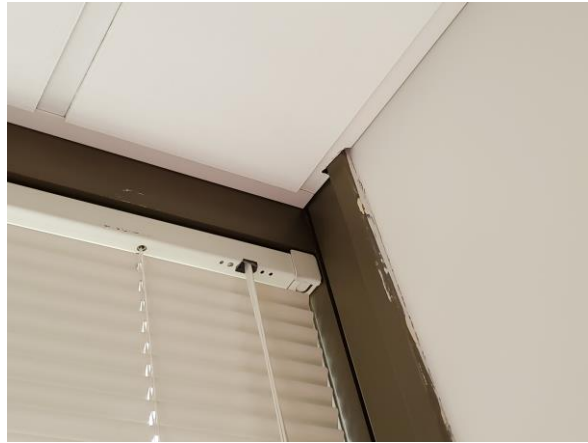
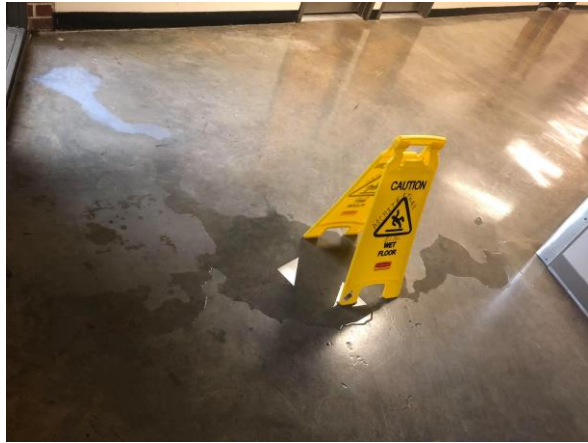
- Water intrusion
- Large open wall areas
- Water through doorways

- Failing joints
- Spalling at deep inset sills
- Standing water at entry walkways

1. Direct Repairs
2. Replacement
3. Progressive Resolution
 1. Dual ETFE System
 2. ETFE System
